Debris/Ice/TPS Assessment and Integrated Photographic Analysis of Shuttle Mission STS-111

Author Name: Armando Oliu

June 2005

June 5, 2002

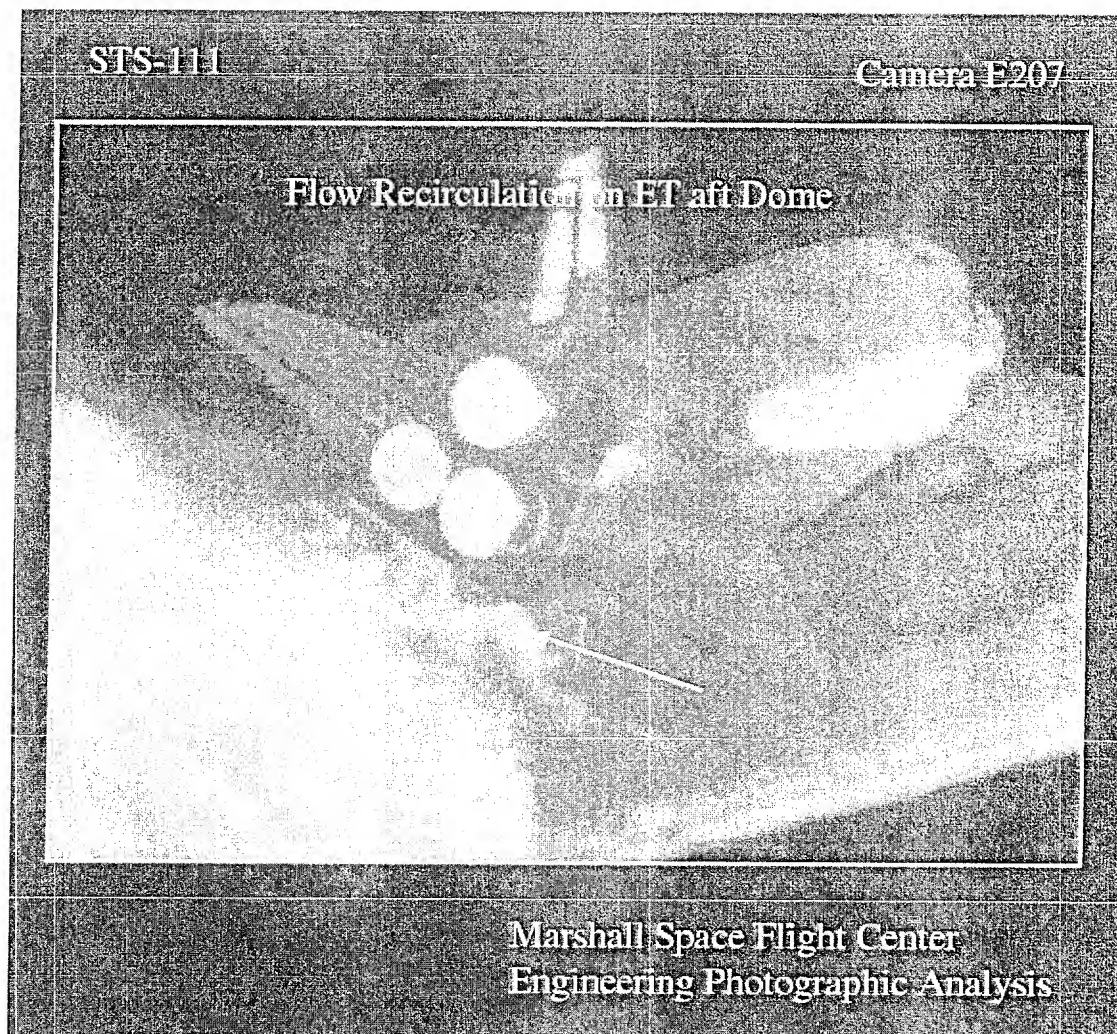
Figure 28. E207: Flow Recirculation

Film Camera E207: Flow Recirculation

Flow recirculation was observed during ascent.

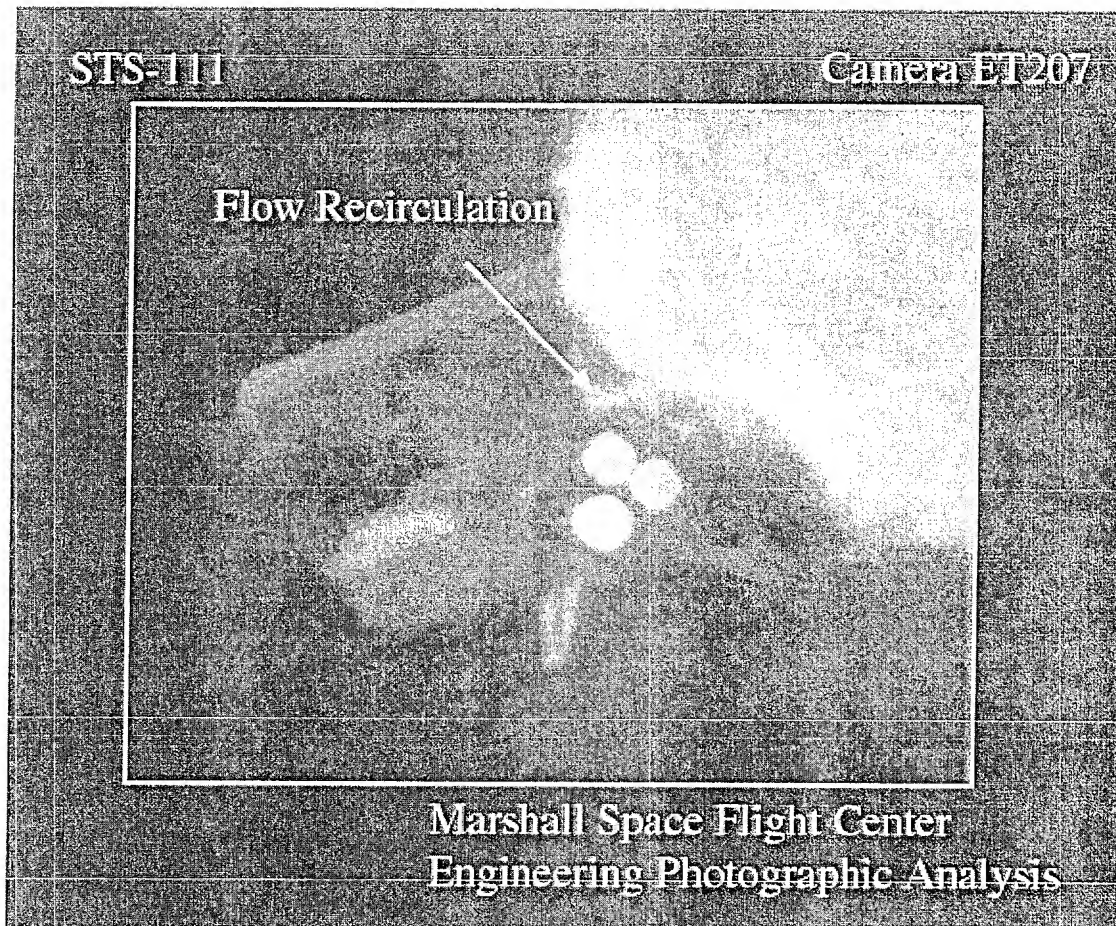
Figure 29. ET207: Flow Recirculation

Video Camera ET207: Flow Recirculation

Flow recirculation was observed during ascent.

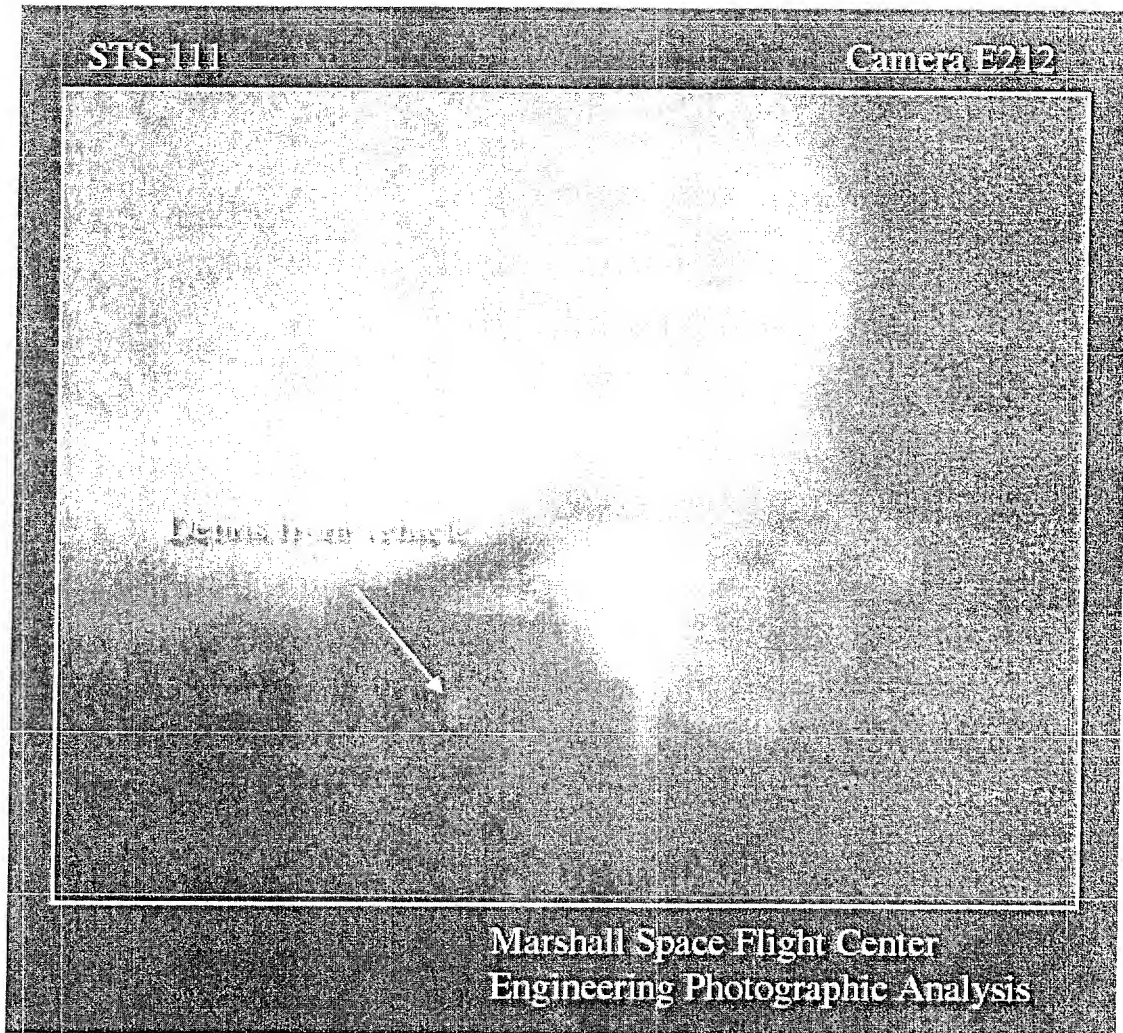
Figure 30. E212: Debris Falling Aft

Film Camera E212: Debris Falling Aft

Debris was observed falling aft of the vehicle during ascent.

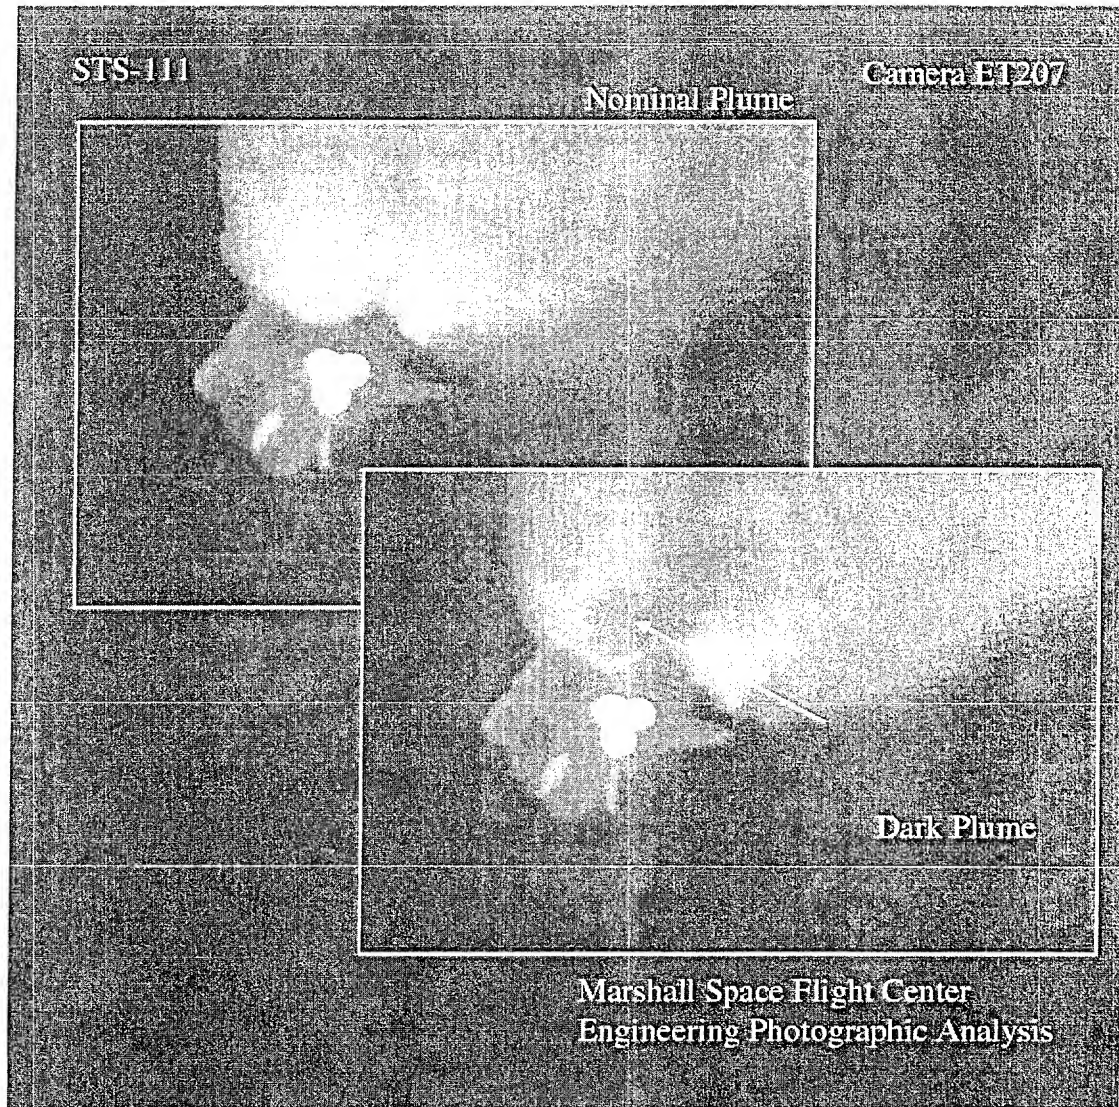
Figure 32. ET207: Dark Plume Event

Video Camera ET207: Dark Plume Event

A closer view of one plume darkening and a comparison to a normal plume in this time frame is shown in Figure 32.

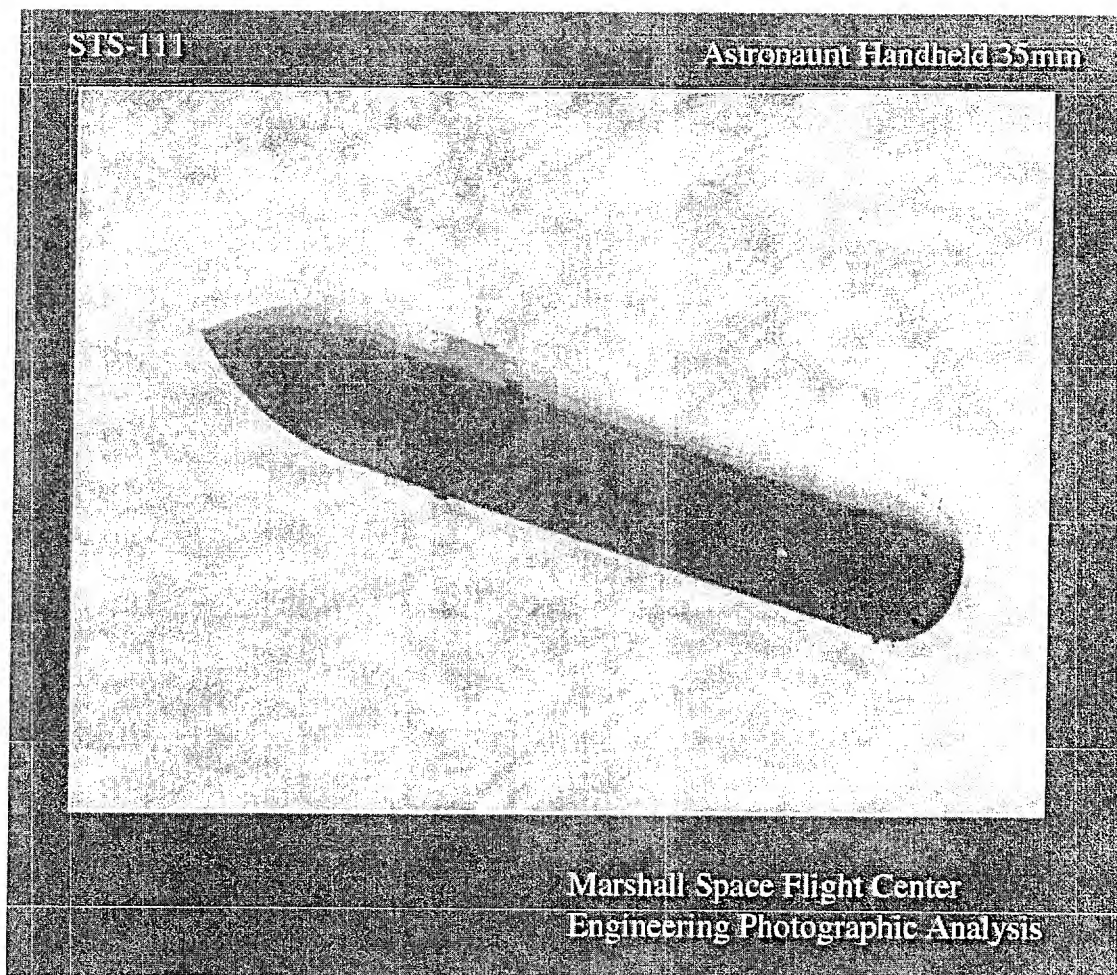
Figure 34. HH35mm: External Tank -Z and -Y Side TPS

Astronaut Handheld 35mm Still Camera: External Tank -Z and -Y Side TPS

The condition of the TPS visible on the -Y and -Z side of the External Tank appeared nominal.

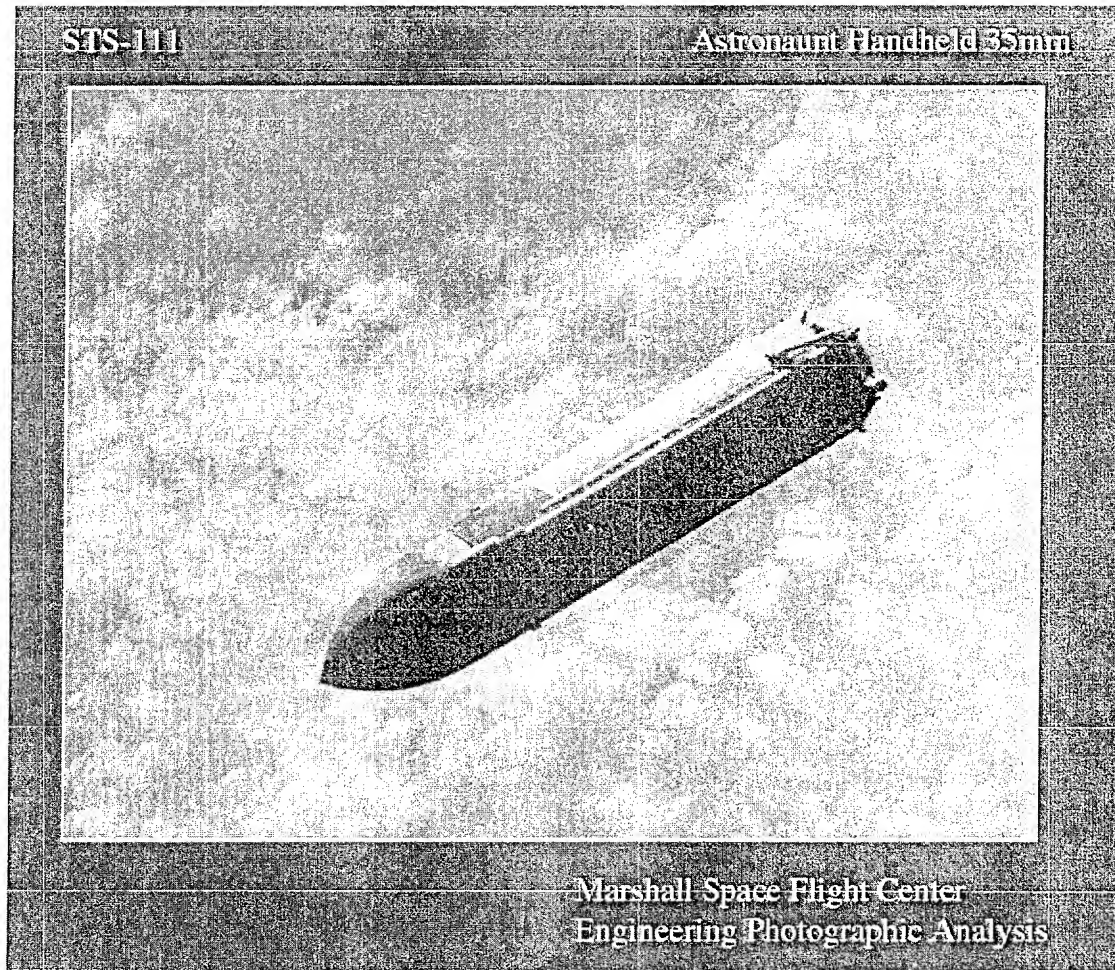
Figure 33. HH35mm: External Tank +Y and +Z Side TPS

Astronaut Handheld 35mm Still Camera: External Tank +Y and +Z Side TPS

The condition of the TPS visible on the +Y and +Z side of the External Tank appeared nominal.

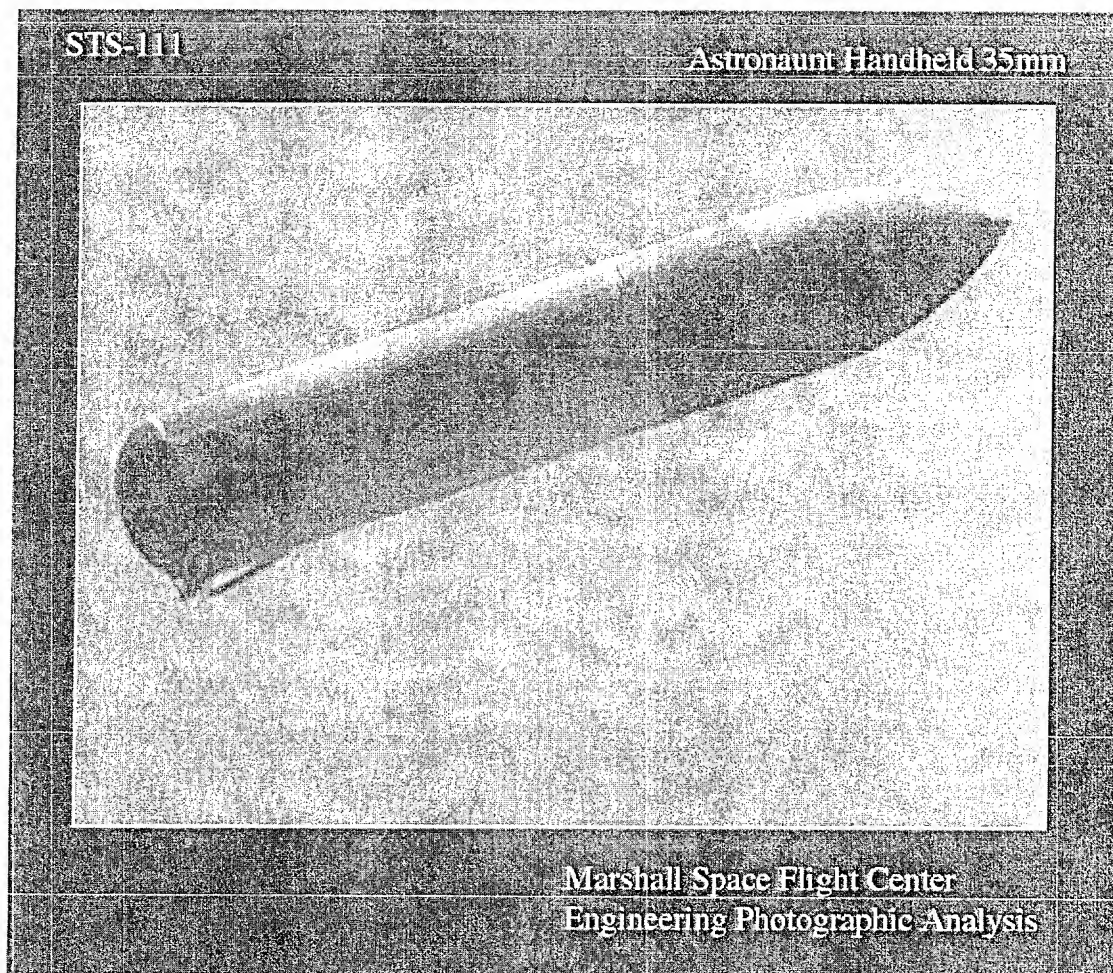
Figure 35. HH35mm: External Tank -Z and -Y Side TPS

Astronaut Handheld 35mm Still Camera: External Tank -Z and -Y Side TPS

The condition of the TPS visible on the +Y and -Z side of the External Tank appeared nominal.

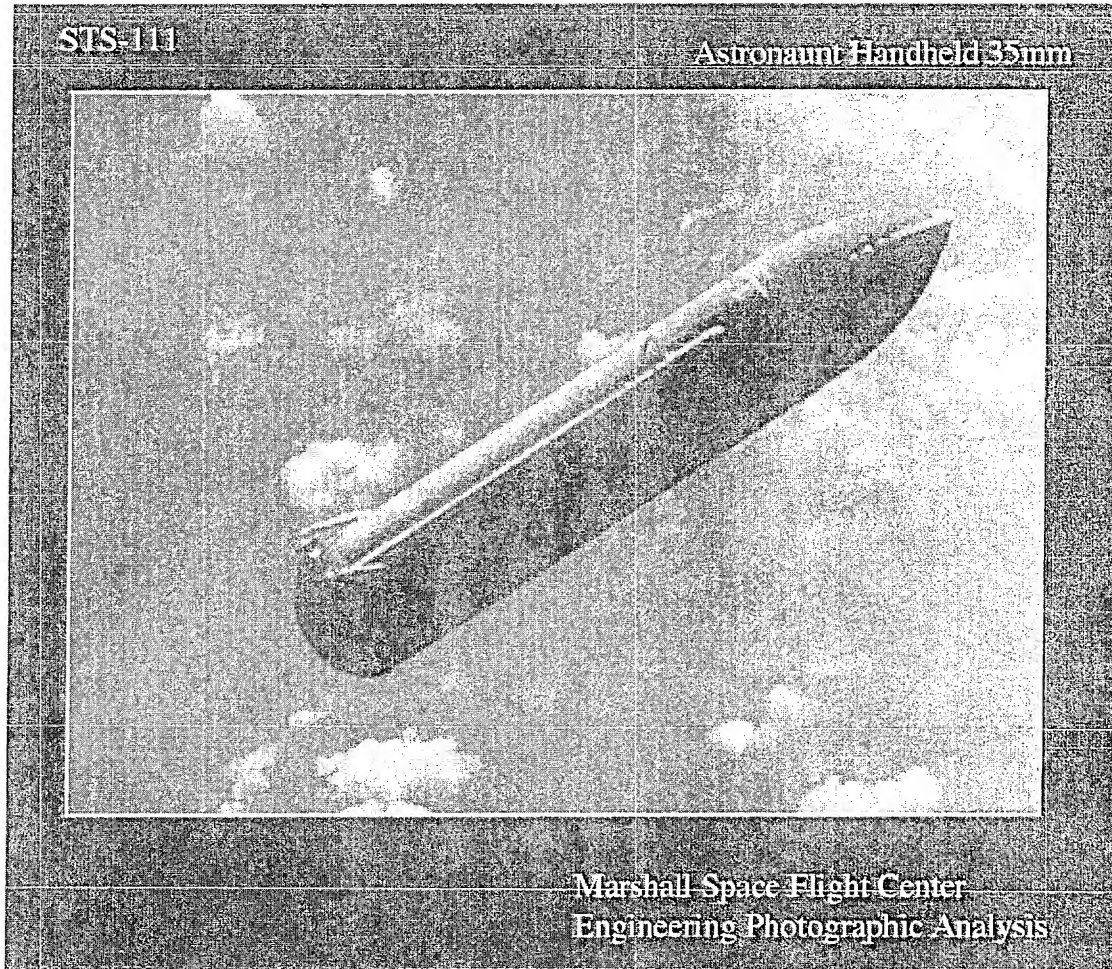
Figure 36. HH35mm: External Tank +Z Side TPS

Astronaut Handheld 35mm Still Camera: External Tank +Z Side TPS

The condition of the TPS visible on the +Z side of the External Tank appeared nominal.

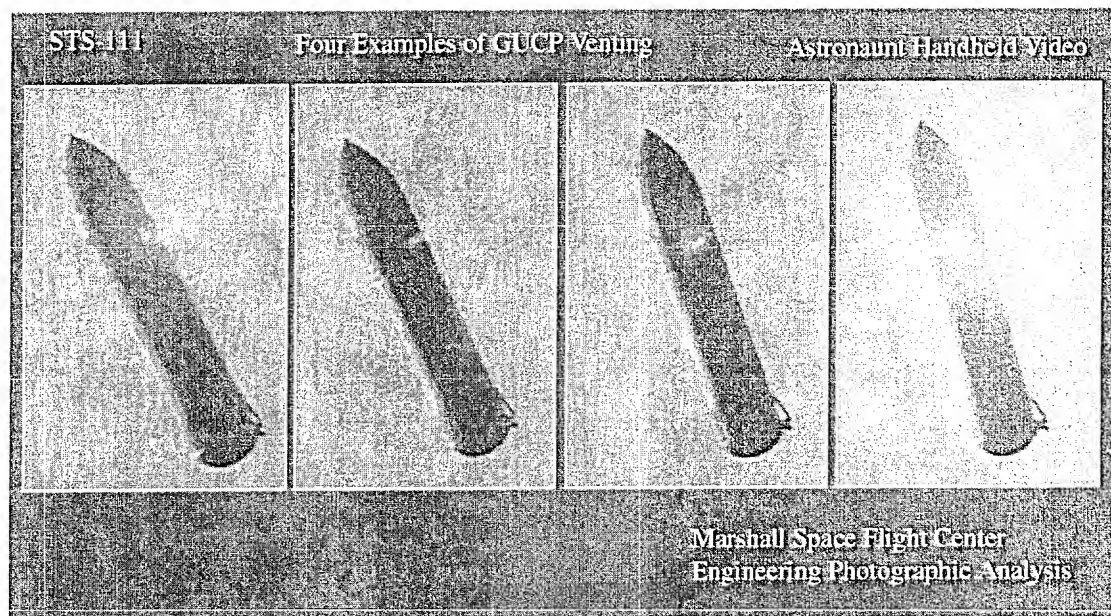
Figure 37. HHVideo: Venting from GUCP after ET/Orbiter Separation

Astronaut Handheld Video Camera: Venting from GUCP after ET/Orbiter Separation

Venting from GUCP was noted after ET/Orbiter separation. Good examples of this venting are illustrated in Figure 37. Venting from the GUCP has been seen on previous missions.

Although fine details could not be discerned, the general condition of TPS appeared good in imagery from the Astronaut Handheld Video camera.

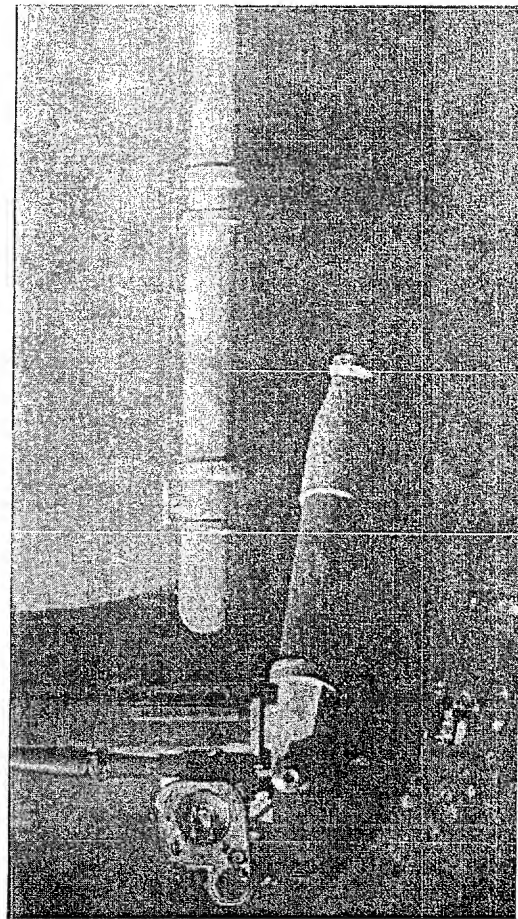
Figure 39 UMB35mm: Frame 20

TPS loss was typical. Normal popcorning and divoting of the aft dome, Figure 38. Typical TPS missing from thrust strut and LO2 feedline, Figure 38 and Figure 39. Divot noted on thrust strut, Figure 38. Three small divots noted, two under and one on the +Y side, near the bipod, Figure 41. One divot on intertank noted near forward -Y side of the LO2 feedline, Figure 43. Nosecap appeared nominal, Figure 44. The purge seal was noted in place around the EO3 joint, Figure 38. Glare from within EO3 joint bore observed, probably a reflection from the chamfer of EO3 bolt, Figure 38. A small positive yaw angle noted as ET moves away from Orbiter is noticeable through the sequence of frames.
